## Maintenance Advice

| Address of Property | 7 Sample Road | | | | |
| Suburb | Sampletown | State | VIC | Postcode | 3000 |
| Date of Assessment | 28 April | | Time of Assessment | 11am | |

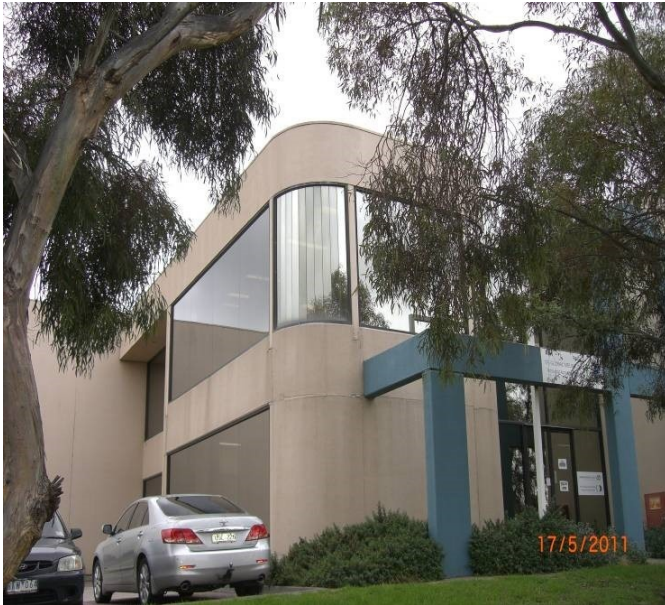
IMG 1

Western and South Western office building elements appear to be more directly exposed to weather - the eastern side being set back more under a canopy over first floor level (items 1 & 2).
