# Property Assessment Report Shop & Office

| Address of Property | 7 Sample Street | | | | |
| Suburb | Sampletown | State | QLD | Postcode | 7000 |
| Date of Assessment | 28 April | | Time of Assessment | 10am | |

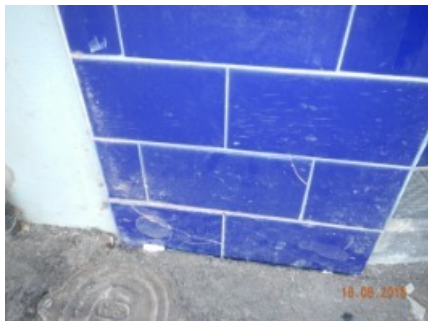
Building on front boundary - No access

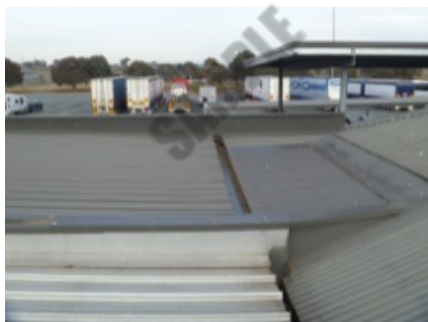
Recommend cleaning box gutters

- 7.Damp detected on ground floor Shop Administration - recommend plumber checks downpipe and repairs.  
 8.Dents in metal deck roof - appear to allow water in. roofer to repair.  
 9.Overhanging tree at courtyard - recommend pruning and regular cleaning of box gutters.  
 10.See Site Notes regarding seepage effects from neighbours.

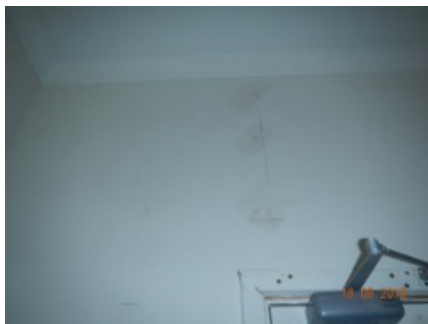
Wall affected by dampness - downpipe leak

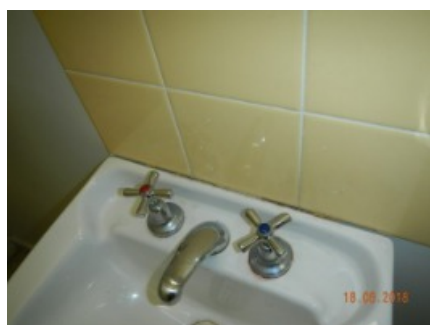
Recommend re-caulking

| 16.Recommend re-caulking splashbacks to basins in both powder rooms. | |
