# Dilapidation Survey Report

| Address of Property | 7 Sample Street | | | | |
| Suburb | Sampletown | State | VIC | Postcode | 3000 |

## DILAPIDATION SURVEY REPORT

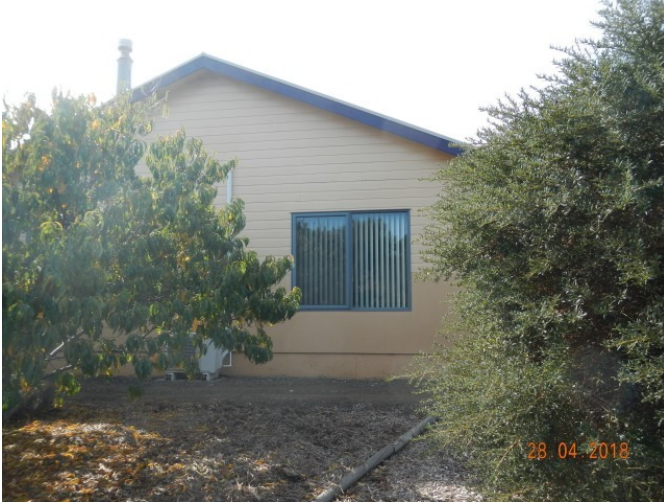
IMG 1

Sample window - out of alignment

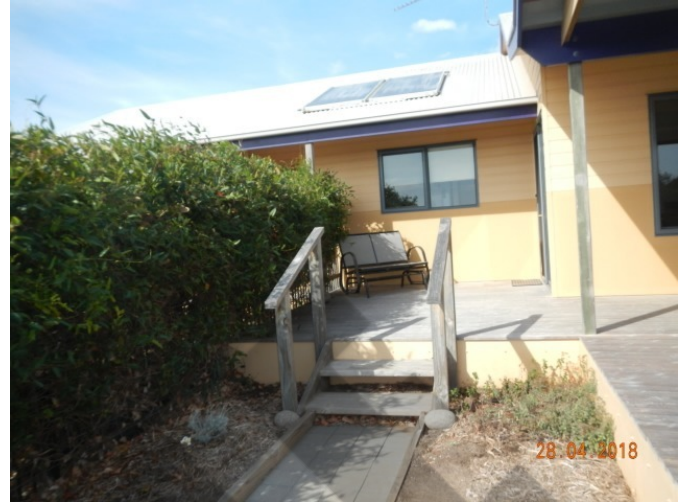
IMG 2

Deteriorated roofing

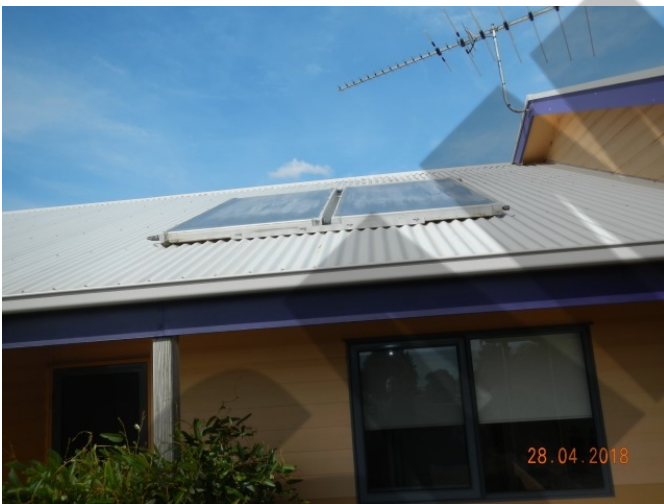
IMG 3

Deteriorated roof

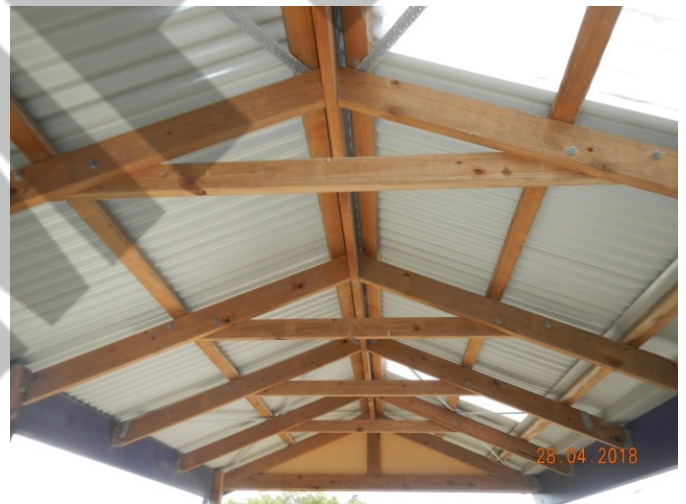
IMG 4

General view - underside of sample - 2mm cracks at beam.

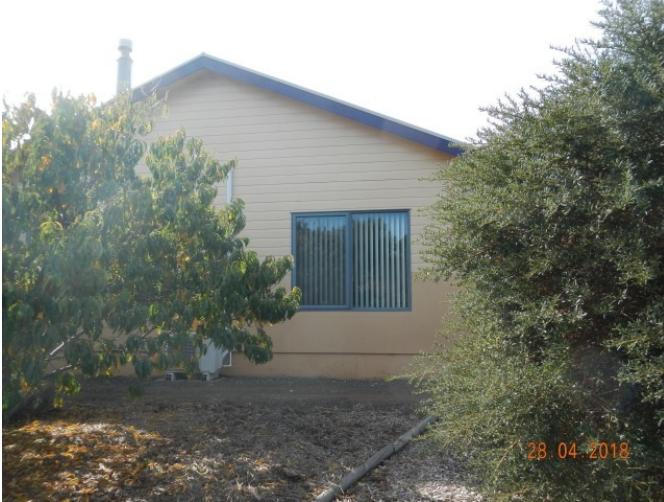
IMG 5

More sample windows - 1-2mm crack at edge

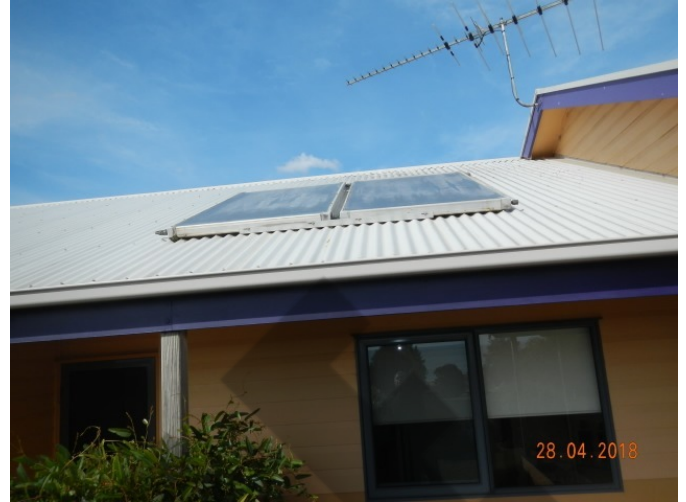
IMG 6

More deterioration sample

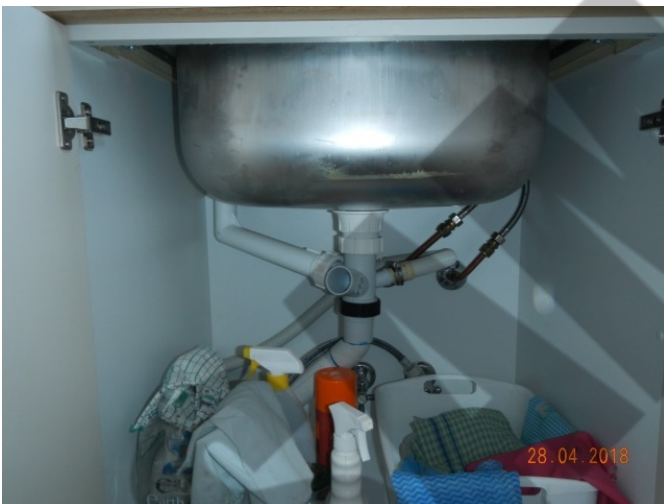
IMG 7

1mm crack in waste pipe
