# Home Access & Services Report

| Address of Property: | 7 Sample Road | | |
| Suburb: | Samptown | State: VIC | Postcode: 3000 |
| Provision of an access ramp into the residence | | | |

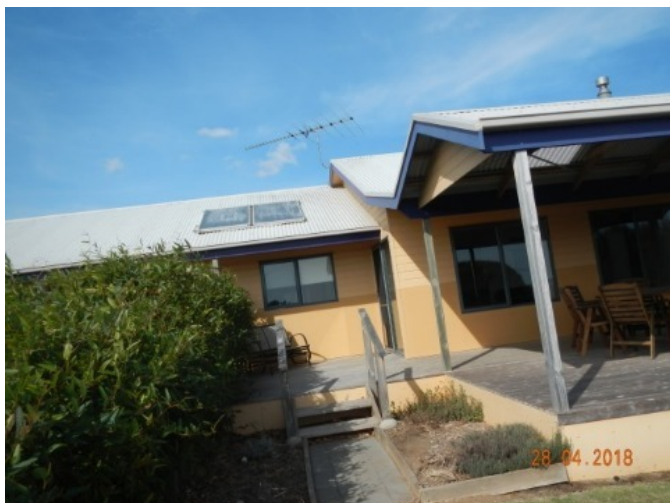
IMG 1

Ramp required in lieu of steps

| Health & Safety Concerns (Urgent - within 1 month) | | | |
|---|---|---|---|
| Safety | Provide even paving at access way to new ramp | Paving - Various | \$700 |
