Dilapidation Survey Report

Address of Property	7 Sample Street				
Suburb	Samletown	State	VIC	Postcode	3000
Date of Inspection	28 April, 2021		Time of Inspection	11 am	
Existing use of Building	Residence				
Weather conditions	Fine				
Verbal summary to	Fred Sample		Date	28 April, 2021

DILAPIDATION SURVEY REPORT SUMMARY

The single storey freestanding building - circa 1995 - appears in reasonable condition.

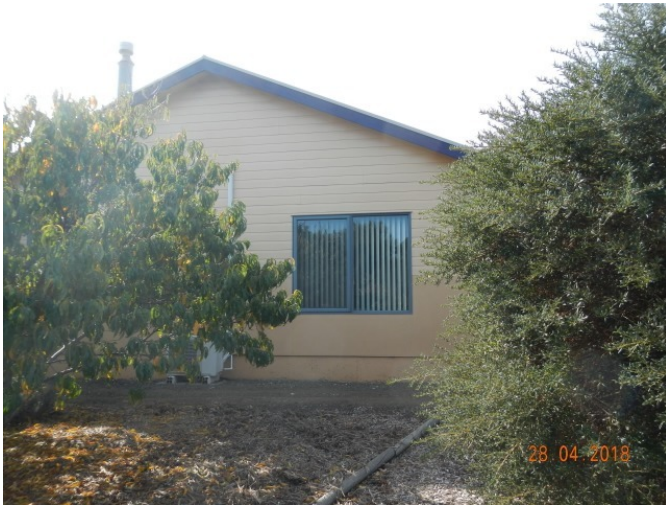
IMG 1

Sample window - out of alignment

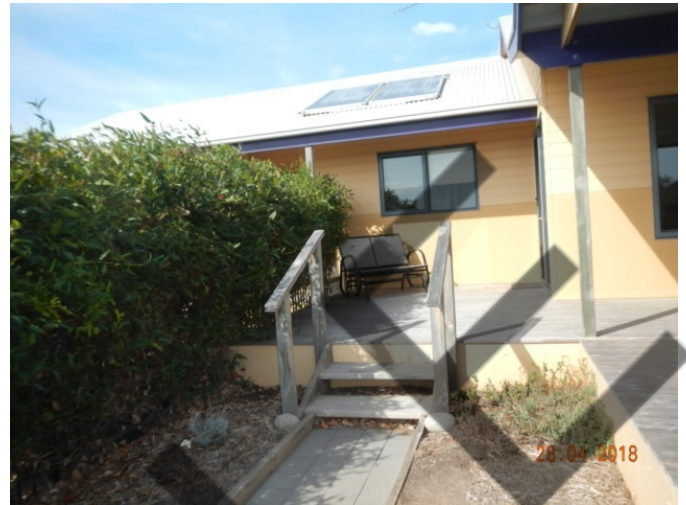
IMG 2

Deteriorated roofing

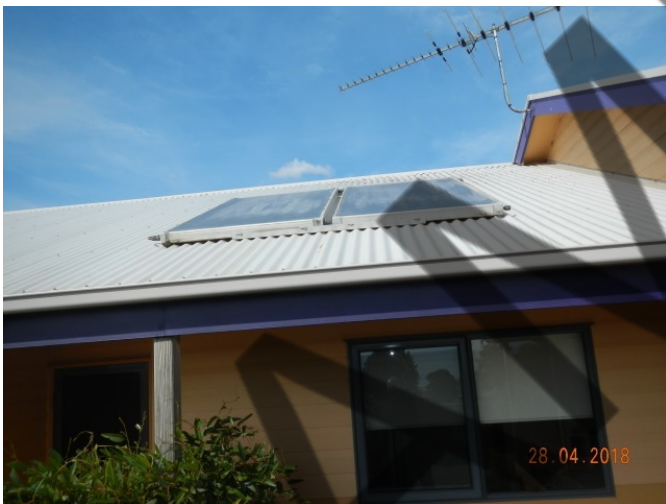
IMG 3

Deteriorated roof

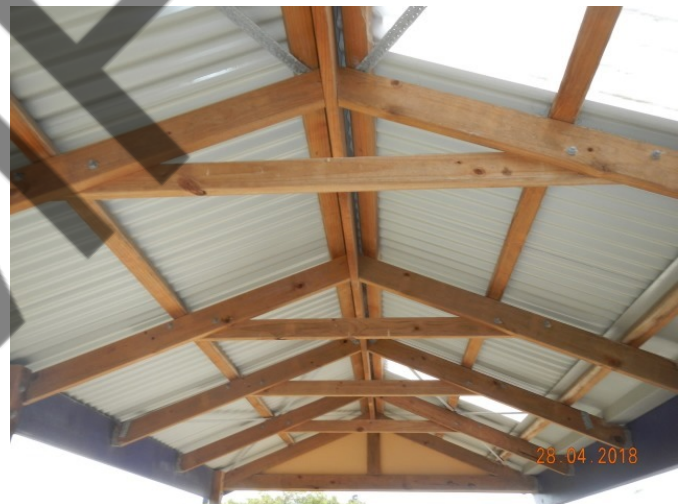
IMG 4

General view - underside of sample - 2mm cracks at beam.

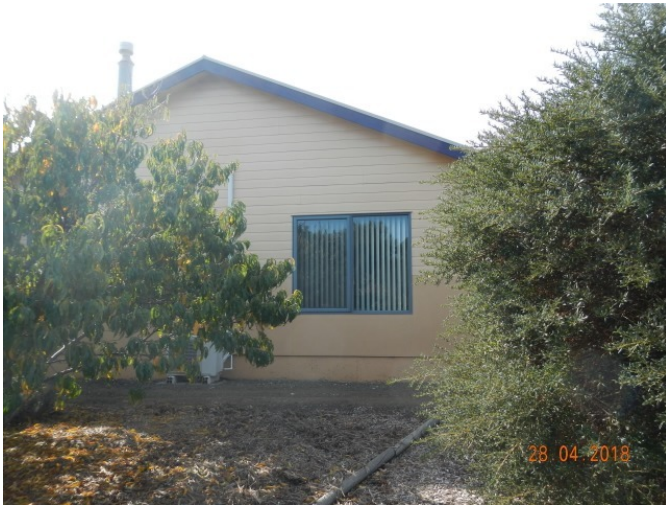
IMG 5

More sample windows - 1-2mm crack at edge

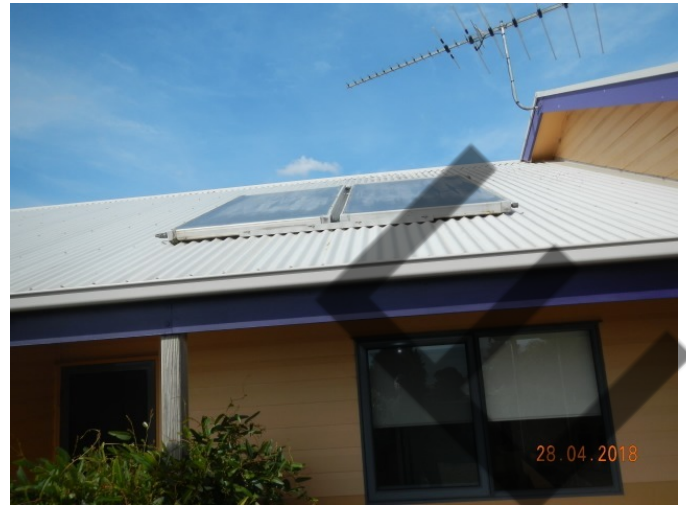
IMG 6

More deterioration sample

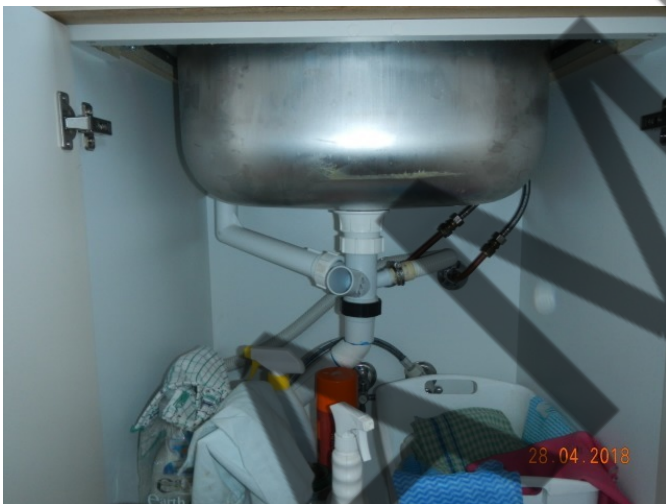
IMG 7

1mm crack in waste pipe
