# Property Assessment Report Shop & Office

Address of Property	7 Sample Street				
Suburb	Sampletown	State	QLD	Postcode	7000
Date of Assessment	28 April		Time of Assessment	10am	
Existing use of Property	Offices				
Weather conditions	Fine				
Verbal summary to	Given in person	Date	28 April

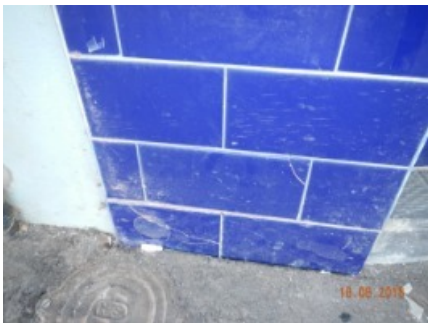
Building on front boundary - No access

<b>Access Limitation</b>	<b>Access Notes</b>
Not Accessible - Obstructed	No access at front of site - building on boundary. Party walls at sides prevent access.
<b>Major and Serious Structural Defects Found:</b>	
<p>1. Seepage from adjacent sites is evident through boundary brick walls - then affecting the building's substructure. Recommend negotiation with neighbours to improve their drainage systems and include additional silt pits within the rear yard to mitigate ground water seepage under the building.</p> <p>2. Garage is adversely affected by seepage through boundary walls. See Summary notes. Within the context of the class 10 facility, seek to negotiate with neighbours to improve site drainage and its deteriorating effects.</p>	
<b>Professional &amp; Trade Recommendations:</b>	Building Contractors, Drainers, Excavating Contractors
<b>Maintenance Items and Minor Defects Found:</b>

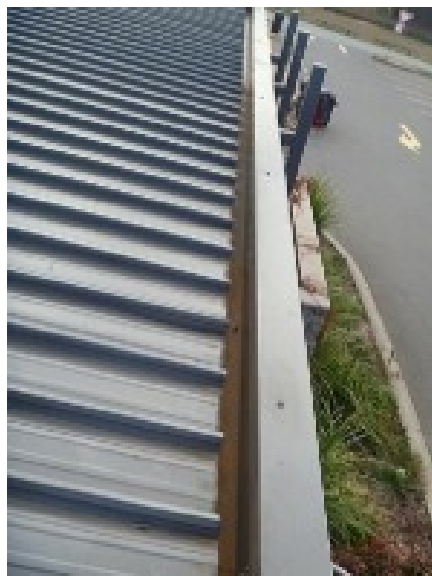
Recommend cleaning box gutters

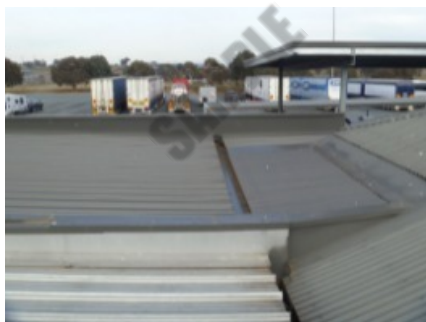
Recommend cleaning box gutters

- 7. Damp detected on ground floor Shop Administration - recommend plumber checks downpipe and repairs.
- 8. Dents in metal deck roof - appear to allow water in. roofer to repair.
- 9. Overhanging tree at courtyard - recommend pruning and regular cleaning of box gutters.
- 10. See Site Notes regarding seepage effects from neighbours.

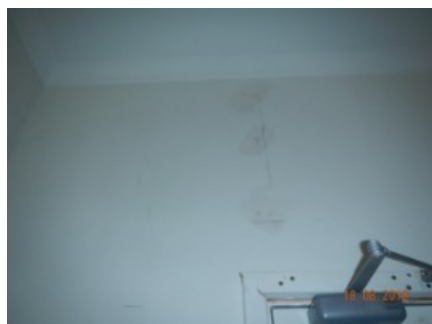
Wall affected by dampness - downpipe leak

<b>Access Limitation</b>	<b>Access Notes</b>
Partially Accessible - Obstructed	Building in use. Fitout and furniture/stored items obstructs full view.
<b>Major and Serious Structural Defects Found:</b>	
12.--	
<b>Professional &amp; Trade Recommendations:</b>	NA
<b>Maintenance Items and Minor Defects Found:</b>	
13.Roof leak confirmed to Office administration area. Recommend roofer repairs.	
<b>Professional &amp; Trade Recommendations:</b>	Roof Const/Repair/Clean
<b>General Notes</b>

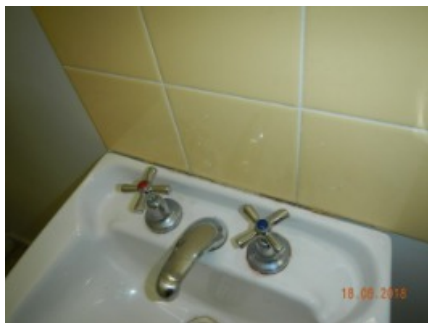
Recommend re-caulking

<b>Access Limitation</b>	<b>Access Notes</b>
Partially Accessible - Obstructed	Building in use. Fitout and furniture/stored items obstructs full view.
<b>Major and Serious Structural Defects Found:</b>	
15.--	
<b>Professional &amp; Trade Recommendations:</b>	NA
<b>Maintenance Items and Minor Defects Found:</b>	
16.Recommend re-caulking splashbacks to basins in both powder rooms.	
<b>Professional &amp; Trade Recommendations:</b>	Tile Layers - Wall/Floor
<b>General Notes</b>	
17.Recommend seeking service checks of services and equipment items - e.g. heating/cooling, hot water services, security, smoke detectors.
