Dilapidation Survey Report

Address of Property	7 Sample Street				
Suburb	Samletown	State	VIC	Postcode	3000
Date of Inspection	28 April		Time of Inspection	11 am	
Existing use of Building	Residence				
Weather conditions	Fine				
Verbal summary to	Fred Sample	Date	28 April

DILAPIDATION SURVEY REPORT

Address: 7 Sample Street Sampletown

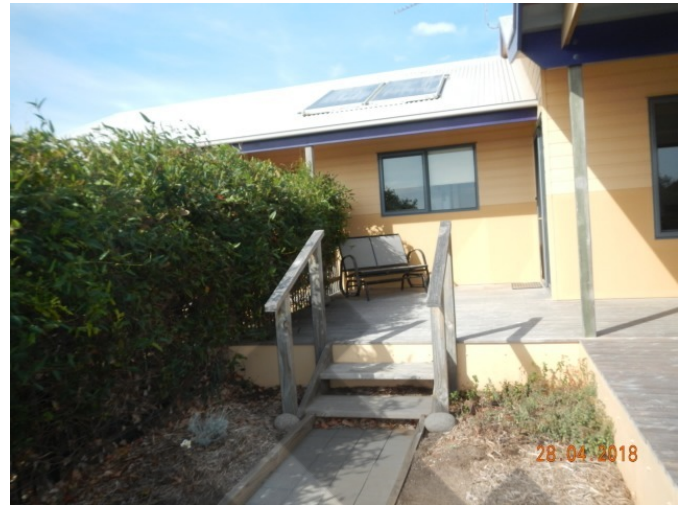
IMG 2

Deteriorated roofing

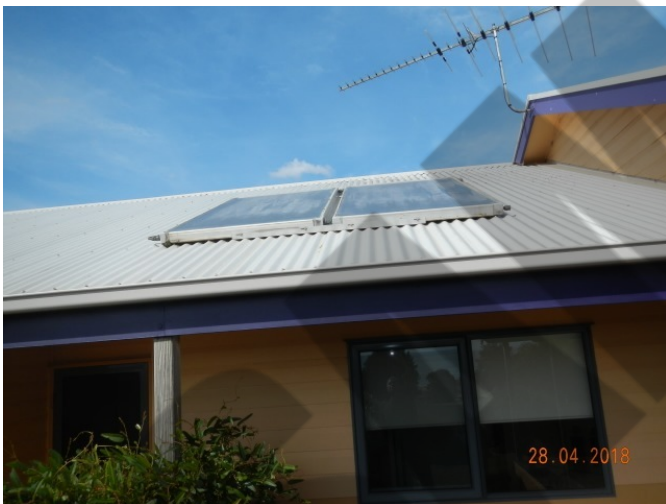
IMG 3

Deteriorated roof

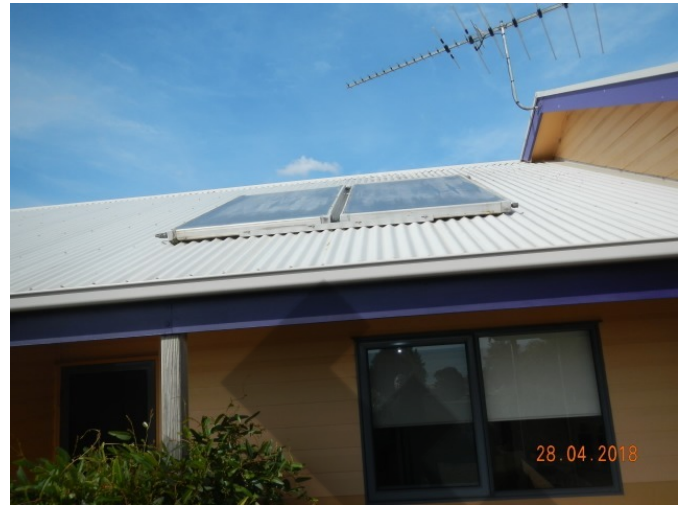
IMG 6

More deterioration sample

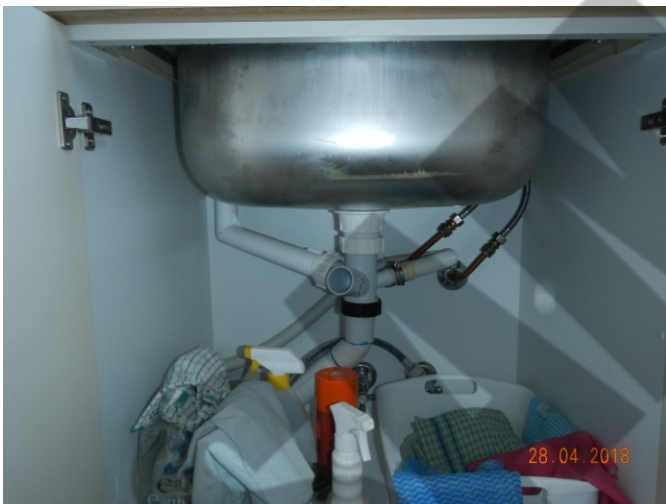
IMG 7

1mm crack in waste pipe
