# Home Access & Services Report

<b>Details Of Advice Sought</b>
Provision of an access ramp into the residence

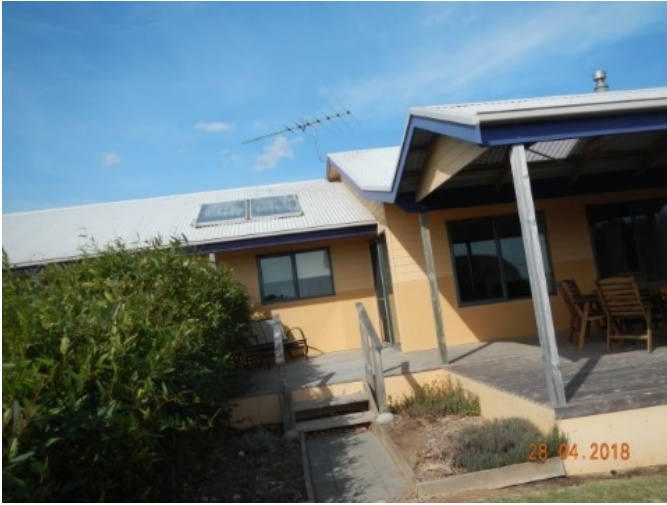
IMG 1

Ramp required in lieu of steps
