Home Access & Services Report

Client Details			
Name:	Fred Sample	Booking No. :	3583
Phone:		Mobile	1234 456 678
Property Details			
Address of Property:	7 Sample Road		
Suburb:	Samletown	State: VIC	Postcode: 3000
Date of Assessment:	28 April, 2018	Time of Assessment:	11am
Existing use of Property:	Single Residence		
Weather conditions:	Fine		
Verbal summary given to:	Fred	Date:	28 April, 2018
Architect Details			
Architect:	Frank Furter	Registration No. :	1234
Address:	8 Simple Street, Samletown		
Email Address:	frank@ furter.com	Phone:	123 345 567
Referred By: Freya - OT		Email Address:	Phone:

Details Of Advice Sought
Provision of an access ramp into the residence

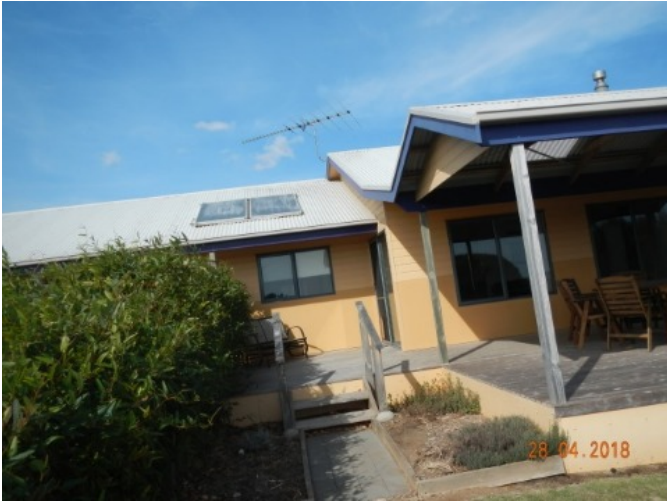
IMG 1

Ramp required in lieu of steps
