# Construction Quality Assurance Assessment Report

Address of Property	7 Sample Street				
Suburb	Sampletown	State	SA	Postcode	5000
Date of Assessment	28 April, 2018		Time of Assessment	11am	
Proposed Use of Building	Single Residence				
Weather conditions	Fine				
Verbal summary to	Fred Sample		Date	28 April, 2018

Address: 7 Sample Street Sampletown

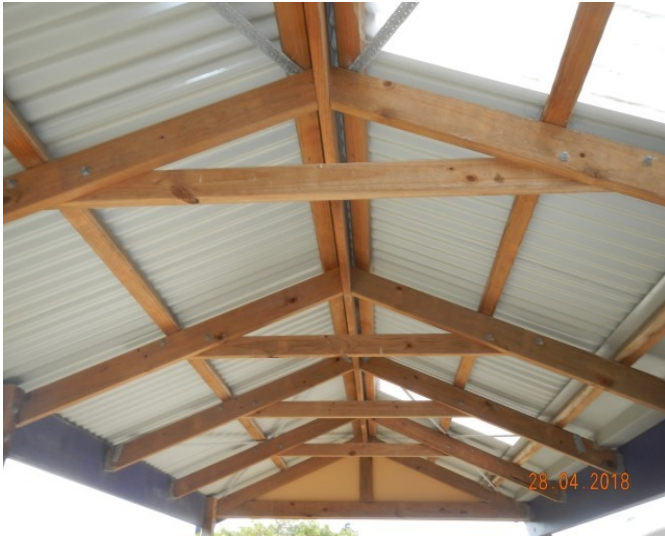
IMG 1

1. Roof trusses need additional fixings
2. Paint has occurred before remedial works have been completed

Paint applied before repairs carried out

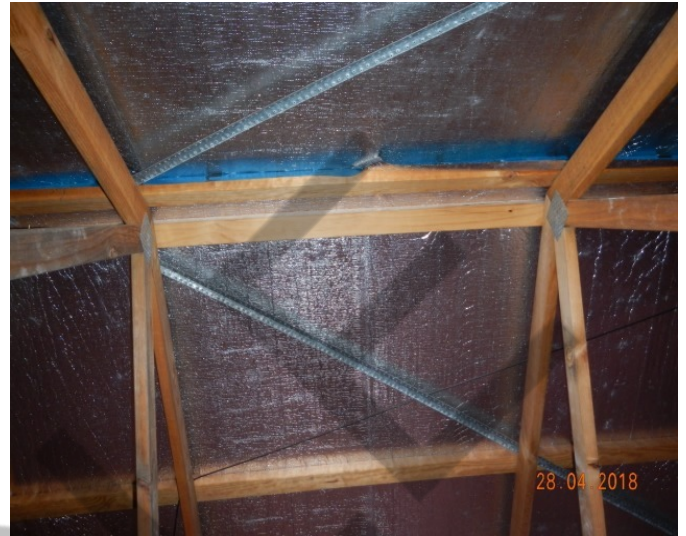
IMG 2

More fixing required

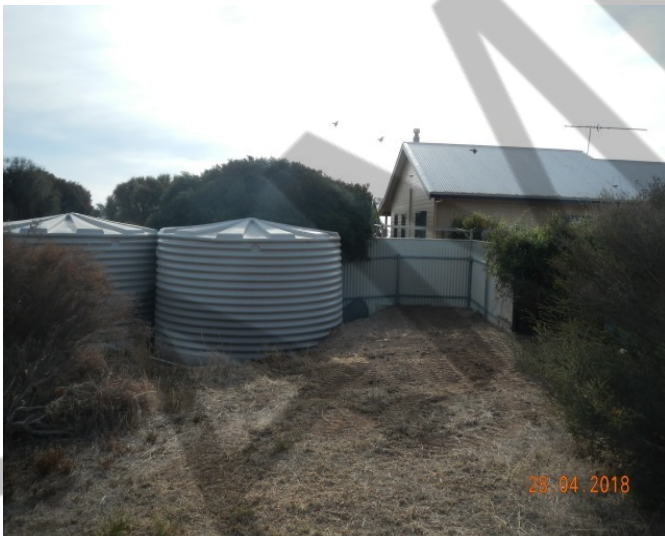
IMG 3

Site	3. und needs to be removed from tanks
Out Buildings & Attached Structures	
External Building Elements	5. sses need fixings
External Access Limitations	6. access to timber deck framing

Ground retained by tanks
