# Timber Pest Inspection Report

| Address of Property | 7 Sample Street | | | | |
| Suburb | Sampletown | State | VIC | Postcode | 3000 |
| Date of Inspection | 28 April | | Time of Inspection | 11am | |

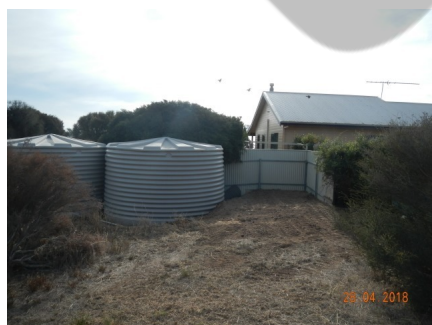
Restrictions to access - tanks, plants

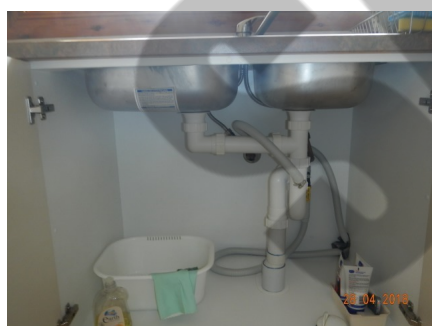
Vermin may access around service pipes

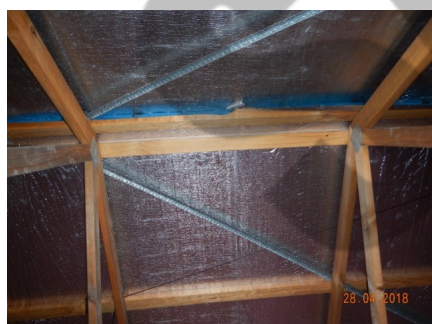
No access to underside of roofing

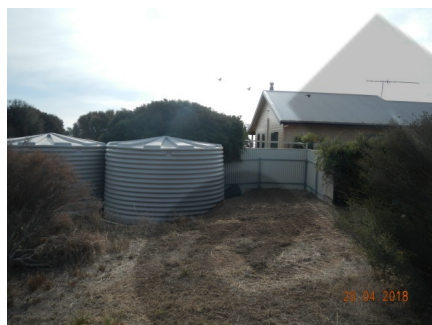
Obstructions.
