# Property Assessment Report Shop & Office

Address of Property	7 Sample Street				
Suburb	Sampletown	State	QLD	Postcode	7000
Date of Assessment	28 April, 2021		Time of Assessment	10am	
Existing use of Property	Offices				
Weather conditions	Fine				
Verbal summary to	Given in person	Date	28 April, 2021

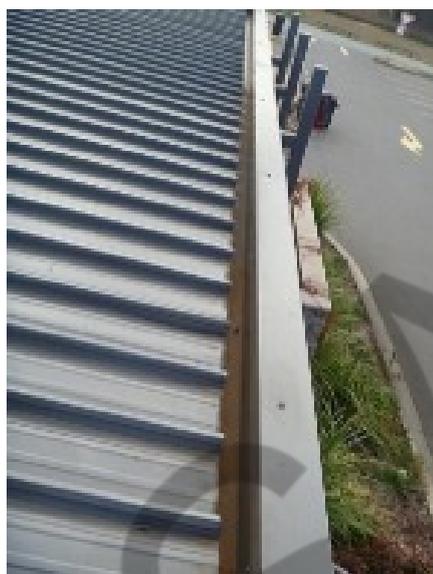
Recommend cleaning box gutters

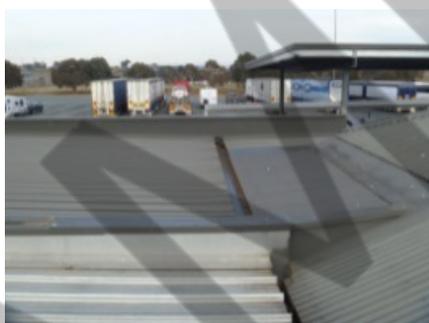
Recommend cleaning box gutters

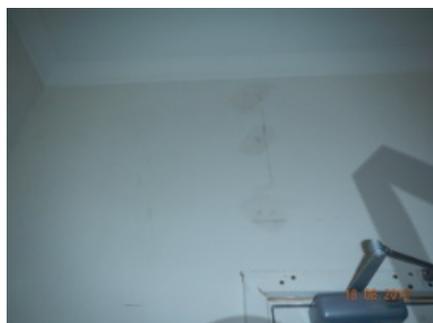
- 7. Damp detected on ground floor Shop Administration - recommend plumber checks downpipe and repairs.
- 8. Dents in metal deck roof - appear to allow water in. roofer to repair.
- 9. Overhanging tree at courtyard - recommend pruning and regular cleaning of box gutters.
- 10. See Site Notes regarding seepage effects from neighbours.

Wall affected by dampness - downpipe leak

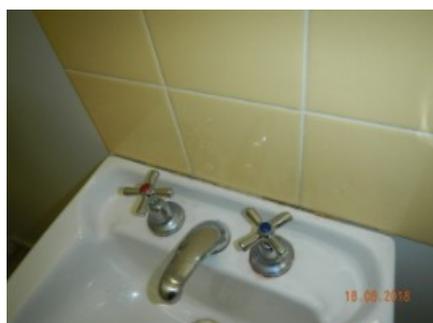
Recommend re-caulking
