Maintenance Advice

Address of Property	7 Sample Road				
Suburb	Sampletown	State	VIC	Postcode	3000
Date of Assessment	28 April, 2018		Time of Assessment	11am	
Existing use of Building	Apartments				
Weather conditions	Fine				
Verbal summary to	Fred		Date	28 April, 2018

The property comprises a 1980's industrial building with a two storey office component – being part of a complex.

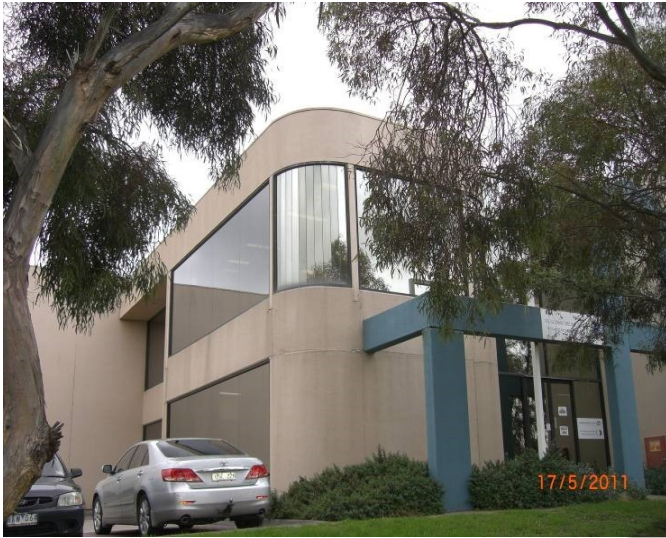
IMG 1

Western and South Western office building elements appear to be more directly exposed to weather – the eastern side being set back more under a canopy over first floor level (items 1 & 2).
