Timber Pest Inspection Report

Address of Property	7 Sample Street				
Suburb	Sampletown	State	VIC	Postcode	3000
Date of Inspection	28 April		Time of Inspection	11am	
Existing use of Building	Residence				
Weather conditions	Fine				
Verbal summary to	Given in person		Date	28 April

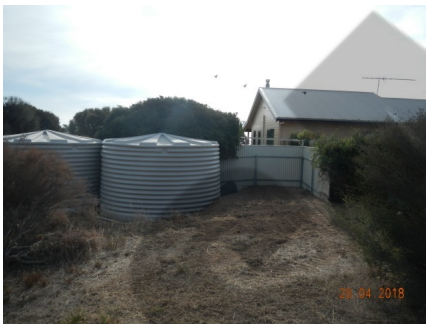
Obstructions.
