# Property Assessment Report

Address of Property	7 Sample Street				
Suburb	Sampletown	State	SA	Postcode	5000
Date of Assessment	28 April, 2018		Time of Assessment	11 am	
Existing use of Property	Residence				
Weather conditions	Fine				
Verbal summary to	Fred Sample	Date	28 April, 2018

PROPERTY SUMMARY - Primary construction materials and site conditions			
Sub-Structure	Concrete Stumps	Floors	Timber
Roof	Corrugated Iron	Walls	Weatherboard
Windows	Aluminium	No of Storeys	2
Site Grade	Gentle Slope	Furnished	Yes
Extension / Renovations	No - likely original	Tree Coverage	Dense
Estimated Age / Period	1950

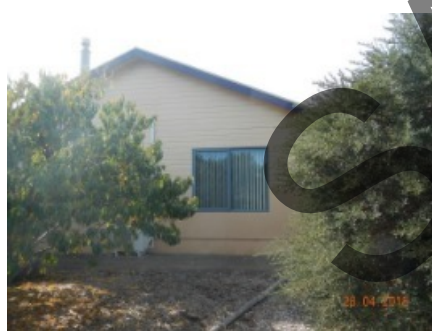
Window racked

Access Limitation	Access Notes
Partially Accessible - Obstructed	Low clearance to some sub-floors
Not Accessible - Obstructed	No access to alfresco sub-floor
<b>Major and Serious Structural Defects Found:</b>	
4. Deteriorated roofing is evident. Recommend monitoring with a view to upgrade. 5. Side wall windows are racked - flyscreens damaged and sliding action is compromised. Recommend detailed assessment with a view to repair or upgrade.	
<b>Professional &amp; Trade Recommendations:</b>	RC BC

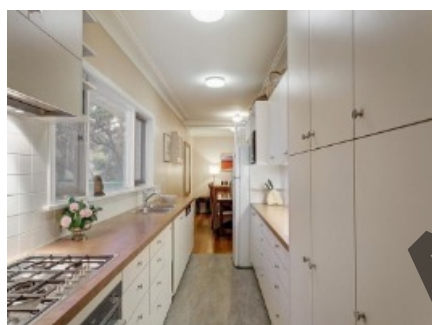
Rangehood exhausts into roof space

<b>Access Limitation</b>	<b>Access Notes</b>
Partially Accessible - Obstructed	Furnished home - stored items too - all prevent full view
<b>Major and Serious Structural Defects Found:</b>	
7.Front bedroom 3 windows are racked - see previous notes.	
<b>Professional &amp; Trade Recommendations:</b>	BC
<b>Maintenance Items and Minor Defects Found:</b>	
8.Rangehood exhausts into roof space. Recommend adding a flue to vent externally. 9.Some damage evident to base cabinets of kitchen. Recommend repair and eventual upgrade.	
<b>Professional &amp; Trade Recommendations:</b>	EL CM BC
<b>General Notes</b>	
NA

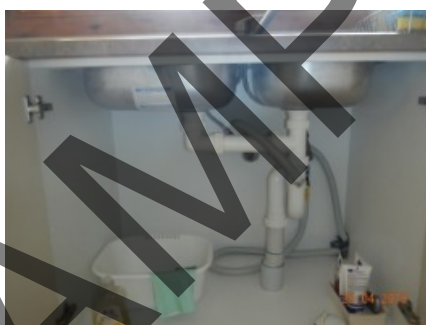
Damaged cabinets

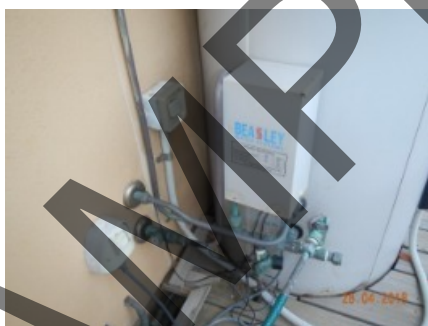
Recommend service check of hws

Access Limitation	Access Notes
Partially Accessible - Obstructed	Furnished home - stored items too - all prevent full view.
<b>Major and Serious Structural Defects Found:</b>	
10.Ensuite and Bathroom windows are racked - see previous notes.	
<b>Professional &amp; Trade Recommendations:</b>	BC
<b>Maintenance Items and Minor Defects Found:</b>	
11.Grout missing from shower recess walls and floor tiles. Recommend cleaning and re-grouting. 12.Older style hot water service. Recommend service check to assess longevity and efficiency.	
<b>Professional &amp; Trade Recommendations:</b>	TL PG
<b>General Notes</b>	
13.Monitor intersections of walls tiles and floor tiles for movement - it is common for waterproofing systems to break down arising out of building movement.
