Home Warranty Inspection Report

Address of Property	7 Sample Street			Lot No	
Suburb	Samletown	State	VIC	Postcode	3000
Municipality	Melbourne		Date of Report	28 April, 2018	
Date of Inspection	28 April, 2018	Time of Arrival	9.30am	Time of Departure	10.30
Weather Conditions:	Fine				
Authorised Building Documents sighted:	No	Stamped Date:	NA

Total House?		Renovations and/or extensions?	Yes
Extent of Renovation and/or Extension Work where relevant (brief description)			
New bedroom, Ensuite			
Extent of Work based on:	Owner's briefing

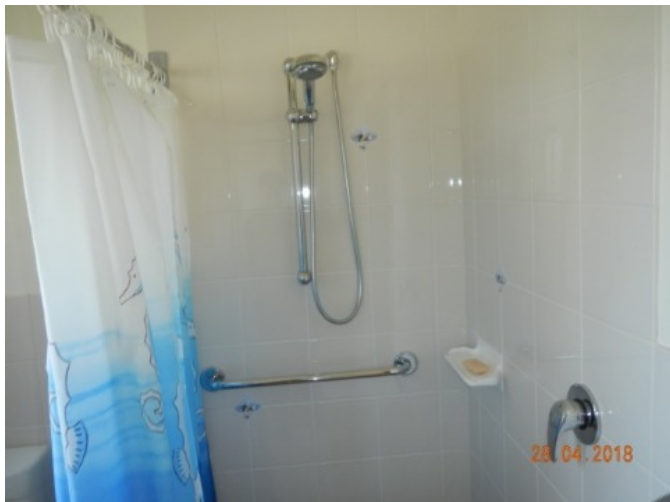
IMG 1

Ensuite shower recess

DEFECTS AND INCOMPLETE WORK EVIDENT AT TIME OF INSPECTION	
Item No	It is recommended that purchasers obtain their own report on the condition of the building
1	Underground system not visually accessible - untested
2	Ground is moist under floor
3	Ducts sit on the ground - should be 150mm up off the sub-floor ground
4	Partial view of some electrical wiring
5	Door furniture is loose; screw missing from plate
6	Ensuite shower in use - walls and recess floors test damp
