Property Assessment Report

Address of Property	7 Sample Street		
Suburb	Sampletown	State	SA
		Postcode	5000
Date of Assessment	28 April, 2018	Time of Assessment	11 am
Existing use of Property	Residence		
Weather conditions	Fine		
Verbal summary to	Given in person	Date	28 April, 2018

This Report is prepared by Archicentre Australia – a division of ArchiAdvisory Pty Ltd – and in accordance with Australian Standard 4349.1-2007 Assessment of Buildings Part 1: Pre-purchase Inspections – Residential Buildings and any other Australian Standards and definitions cited in the Terms and Conditions.

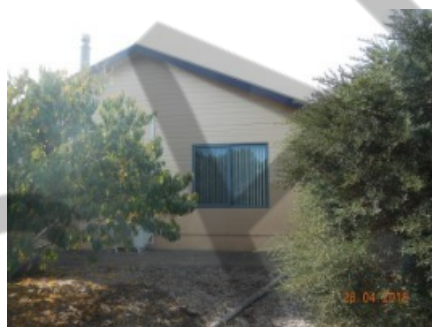
Window racked

Access Limitation	Access Notes
Partially Accessible - Inspection Safety Hazard	Low clearance to some sub-floors
Not Accessible - Obstructed	No access to alfresco sub-floor
Major and Serious Structural Defects Found:	
6. Deteriorated roofing is evident. Recommend monitoring with a view to upgrade.	
Professional & Trade Recommendations:	Roof Const/Repair/Clean
Maintenance Items and Minor Defects Found:	
7. Side wall windows are racked - flyscreens damaged and sliding action is compromised. Recommend detailed assessment

8.with a view to repair or upgrade.

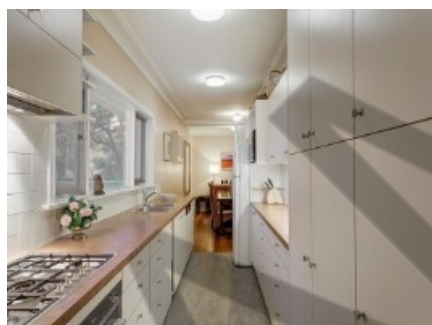
Rangehood exhausts into roof space

Access Limitation	Access Notes
Partially Accessible - Obstructed	Furnished home - stored items too - all limit full view
Major and Serious Structural Defects Found:	
12.Front bedroom 3 windows are racked - see previous notes.	
Professional & Trade Recommendations:	Building Contractors
Maintenance Items and Minor Defects Found:	
13.Rangehood exhausts into roof space. Recommend adding a flue to vent externally. 14.Some damage evident to base cabinets of kitchen. Recommend repair and eventual upgrade.	
Professional & Trade Recommendations:	Building Contractors, Cabinet Makers, Electrical Contractors
General Notes	
15.--

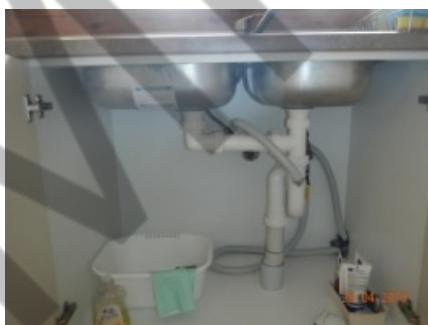
Damaged cabinets
