# Property Assessment Report

| Address of Property | 7 Sample Street | | | | |
| Suburb | Sampletown | State | VIC | Postcode | 3000 |
| Date of Assessment | 28 April, 2021 | | Time of Assessment | 11am | |

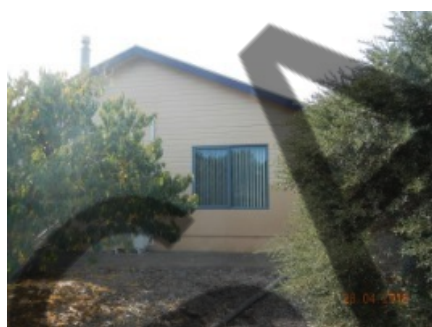
Window racked

7.Side wall windows are racked - flyscreens damaged and sliding action is compromised. Recommend detailed assessment  
8.with a view to repair or upgrade.  
9.Gutters filled with debris can cause premature deterioration. Some downpipes appear blocked. Recommend thorough  
10.cleaning and testing of the piped stormwater system .

| 12.Front bedroom 3 windows are racked - see previous notes. | |

| 16. Ensuite and Bathroom windows are racked - see previous notes. | |

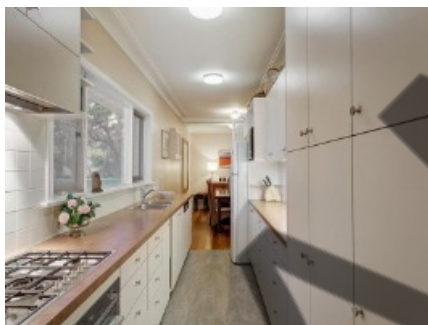
Rangehood exhausts into roof space

| 13.Rangehood exhausts into roof space. Recommend adding a flue to vent externally.<br>14.Some damage evident to base cabinets of kitchen. Recommend repair and eventual upgrade. | |

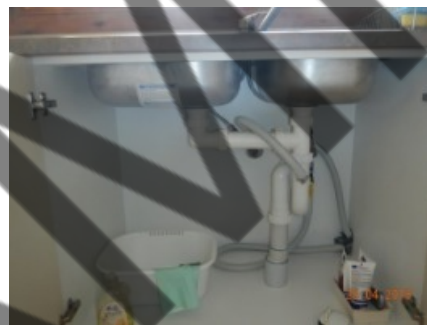
Damaged cabinets

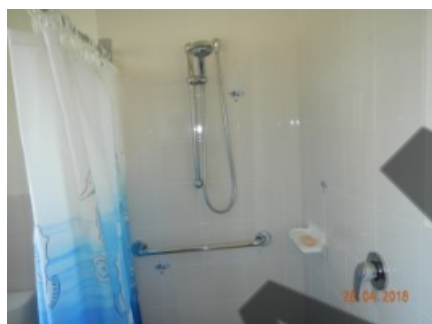
Shower recess tiles to re-grout

| 17. Grout missing from shower recess walls and floor tiles. Recommend cleaning and re-grouting.<br>18. Older style hot water service. Recommend service check to assess longevity and efficiency. Electric element may have reached its life expectancy. | |

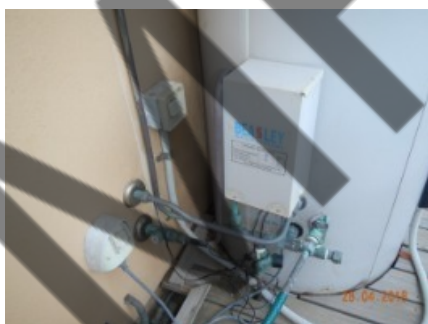
Recommend service check of hws
