# Home Warranty Inspection Report

| INSPECTION DETAILS | | | | | |
|---|---|---|---|---|---|
| Address of Property | 7 Sample Street | | | Lot No | |

| New bedroom, Ensuite | | | |

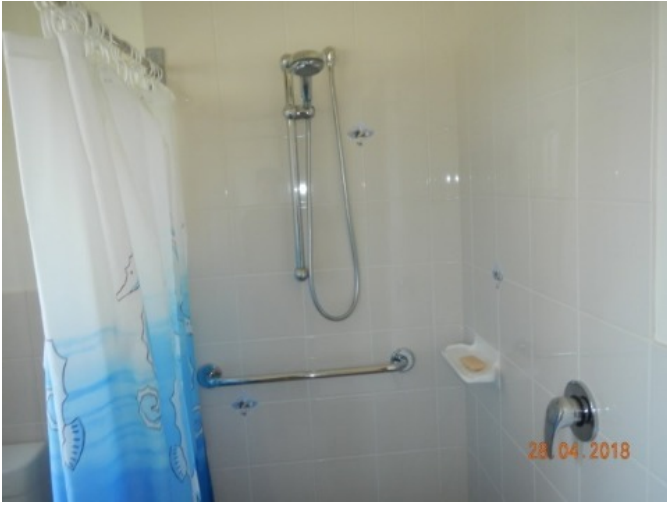
IMG 1

Ensuite shower recess

| DEFECTS AND INCOMPLETE WORK EVIDENT AT TIME OF INSPECTION | |
|---|---|
| 6 | Ensuite shower in use - walls and recess floors test damp |
