Architect's Advice Report

Address of Property	7 Sample Street				
Suburb	Samletown	State	SA	Postcode	5000
Date of Assessment	28 April	Time of Assessment	11 am		
Proposed Use of Building	Residence				
Weather conditions	Fine				
Verbal summary to	Fred Sample	Date	28 April

Sample - Provide advice on the effect of rusting roof fixings to the colorbond roof system.

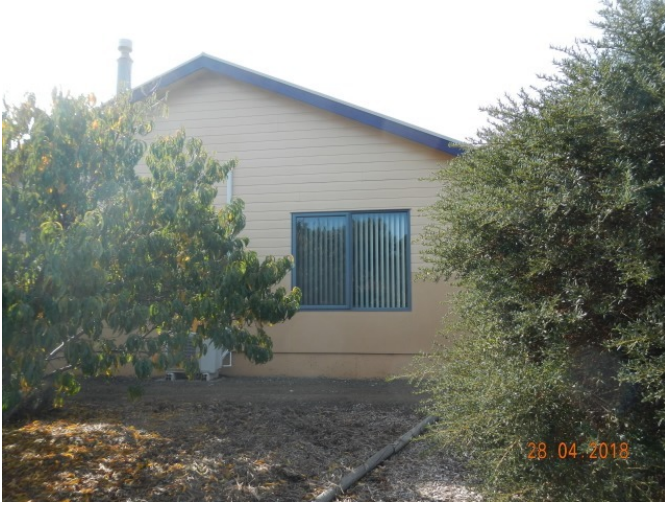
IMG 1

Of particular concern is the apparent deterioration of fixings to the colorbond roof system. This widespread across all aspects - suggesting inadequate coating of roofing screws at manufacture.

While not excessively deteriorated, the fixings can become a source for deterioration to the roofing and accordingly cause premature need for its replacement.

Cappings to gable end to home

It is recommended that a roof plumber replace roof fixings to avoid any further opportunity to cause deterioration of roofing.

In doing so, thoroughly clean down the roof system - check all flashings, cappings and gutters.

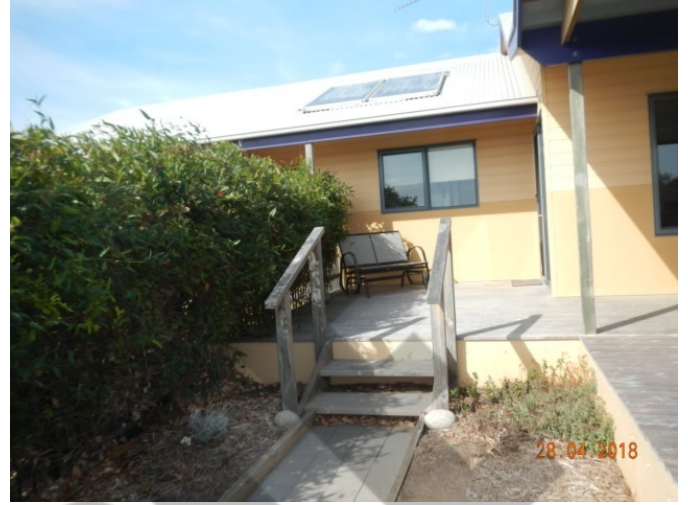
IMG 2

Solar hot water panels - check penetrations.

Flues and service penetrations to the solar hot water panels should be assessed for efficacy.
