Home Warranty Inspection Report

Address of Property	7 Sample Street			Lot No	
Suburb	Samletown	State	VIC	Postcode	3000
Municipality	Melbourne		Date of Report	28 April	
Date of Inspection	28 April	Time of Arrival	9.30am	Time of Departure	10.30am
Weather Conditions:	Fine				
Authorised Building Documents sighted:	No	Stamped Date:	NA

Total House?		Renovations and/or extensions?	Yes
Extent of Renovation and/or Extension Work where relevant (brief description)			
New bedroom, Ensuite			
Extent of Work based on:	Owner's briefing

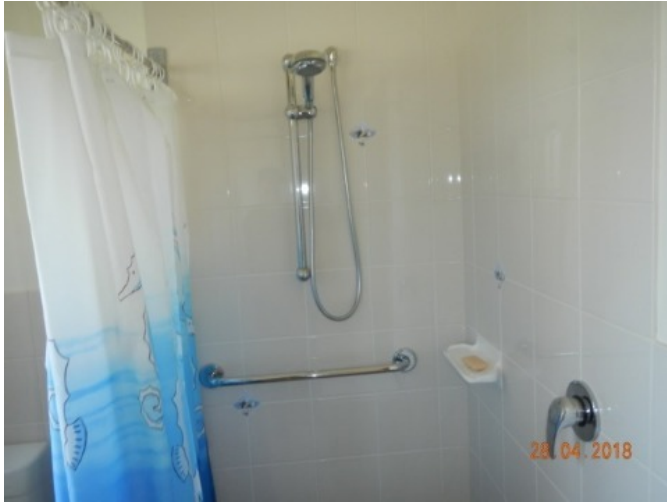
IMG 1

Ensuite shower recess

DEFECTS AND INCOMPLETE WORK EVIDENT AT TIME OF INSPECTION	
Item No	It is recommended that purchasers obtain their own report on the condition of the building
1	Underground system not visually accessible - untested
2	Ground is moist under floor
3	Ducts sit on the ground - should be 150mm up off the sub-floor ground
4	Partial view of some electrical wiring
5	Door furniture is loose; screw missing from plate
6	Ensuite shower in use - walls and recess floors test damp
